# TeraPrint Produktunterlage

| UNTERLAGE | Anti-Rutsch-Zertifikat |

# TEST REPORT

Sample Name : AMF-N/S  
Material and Mark : Adhesive Film (Aluminum)  
Other Information : Colour: White

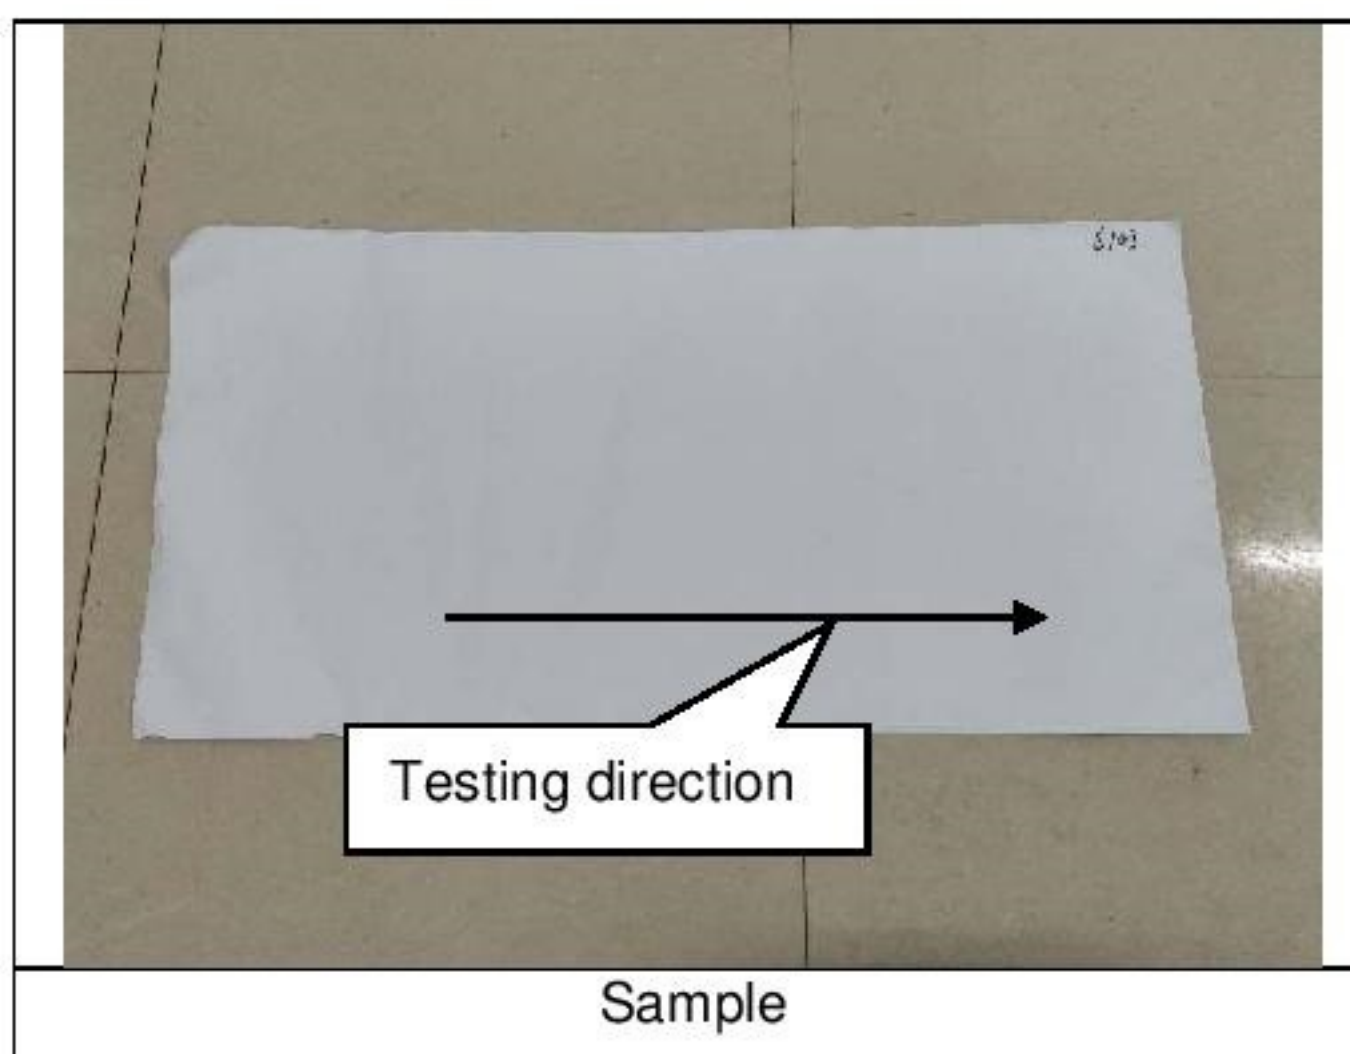
### Original Sample Photo:

Sample Description: Flooring, See photo

Specimen: 1000mm×500mm, 1pc, see photo
